## **Geologic Controls of Sand Boil Formation at Buck Chute, Mississippi**

June 2017

Final report

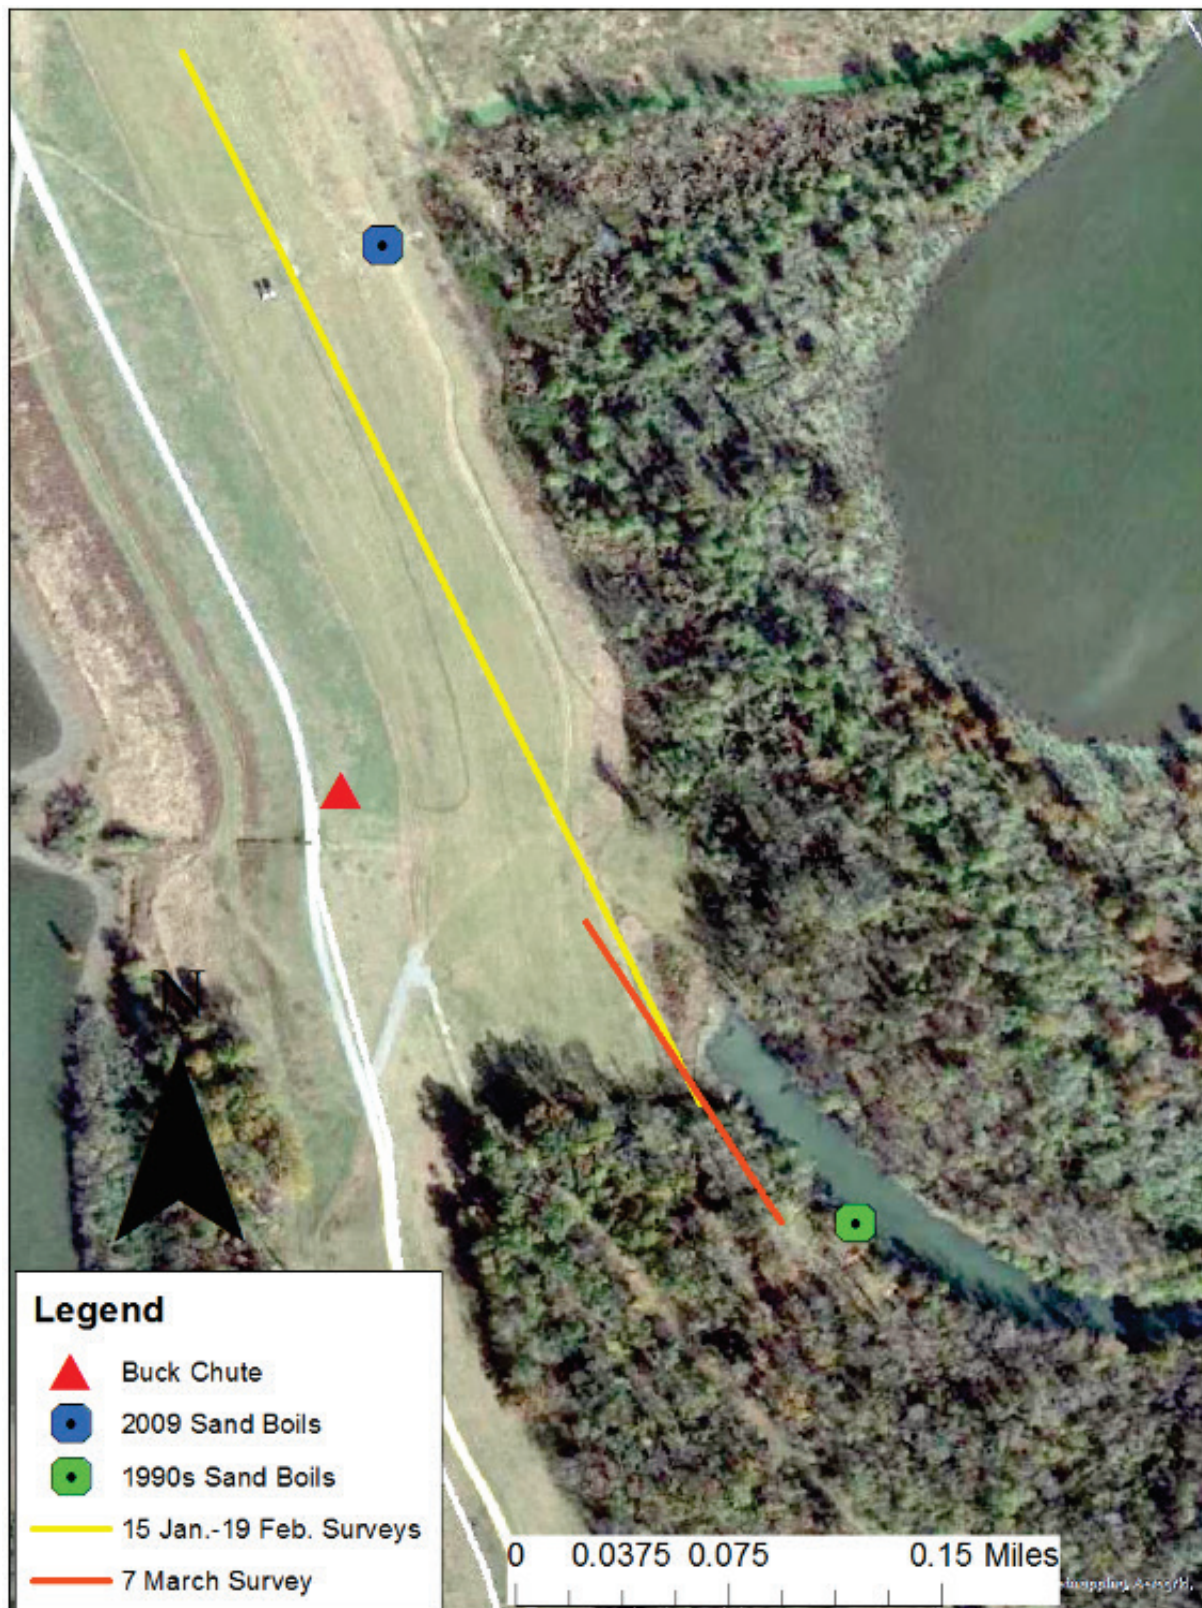
Figure 14. Location of ERT surveys relative to sand boil activity (Modified from World Imagery base map downloaded from ESRI ArcMap 10.1 library).

Five surveys performed from 15 January 2014 through 19 February 2014 were combined during processing. The 7 March 2014 ERT survey was conducted and processed separately from the combined survey. The combined survey begins in the south at the wood line and trends northwest on the seepage berm paralleling the levee at Buck Chute (Figure 14). The line was chosen to intersect the batture channel and seepage paths of the 2009 sand boils. The combined survey results displayed relatively uniform thickness, low-resistivity, top stratum, and more highly resistive substratum (Figure 15). Near the 2009 sand boil activity, an area of higher resistivity values occurs. This is interpreted as coarse, clean sands that have a higher hydraulic conductivity than the surrounding material and therefore is a potential seepage path.

The 7 March 2014 survey was performed to identify possible seepage pathways for the 1990s sand boil occurrences; however, the survey could not be extended far enough south because surface conditions prevented emplacement of electrodes. Due to the orientation of the path through the woods in the southern portion of the study area, the survey was not able to be combined with the 15 January through 19 February surveys. The results are interpreted as a blanket, which thins rapidly from the north to the south (Figure 16).

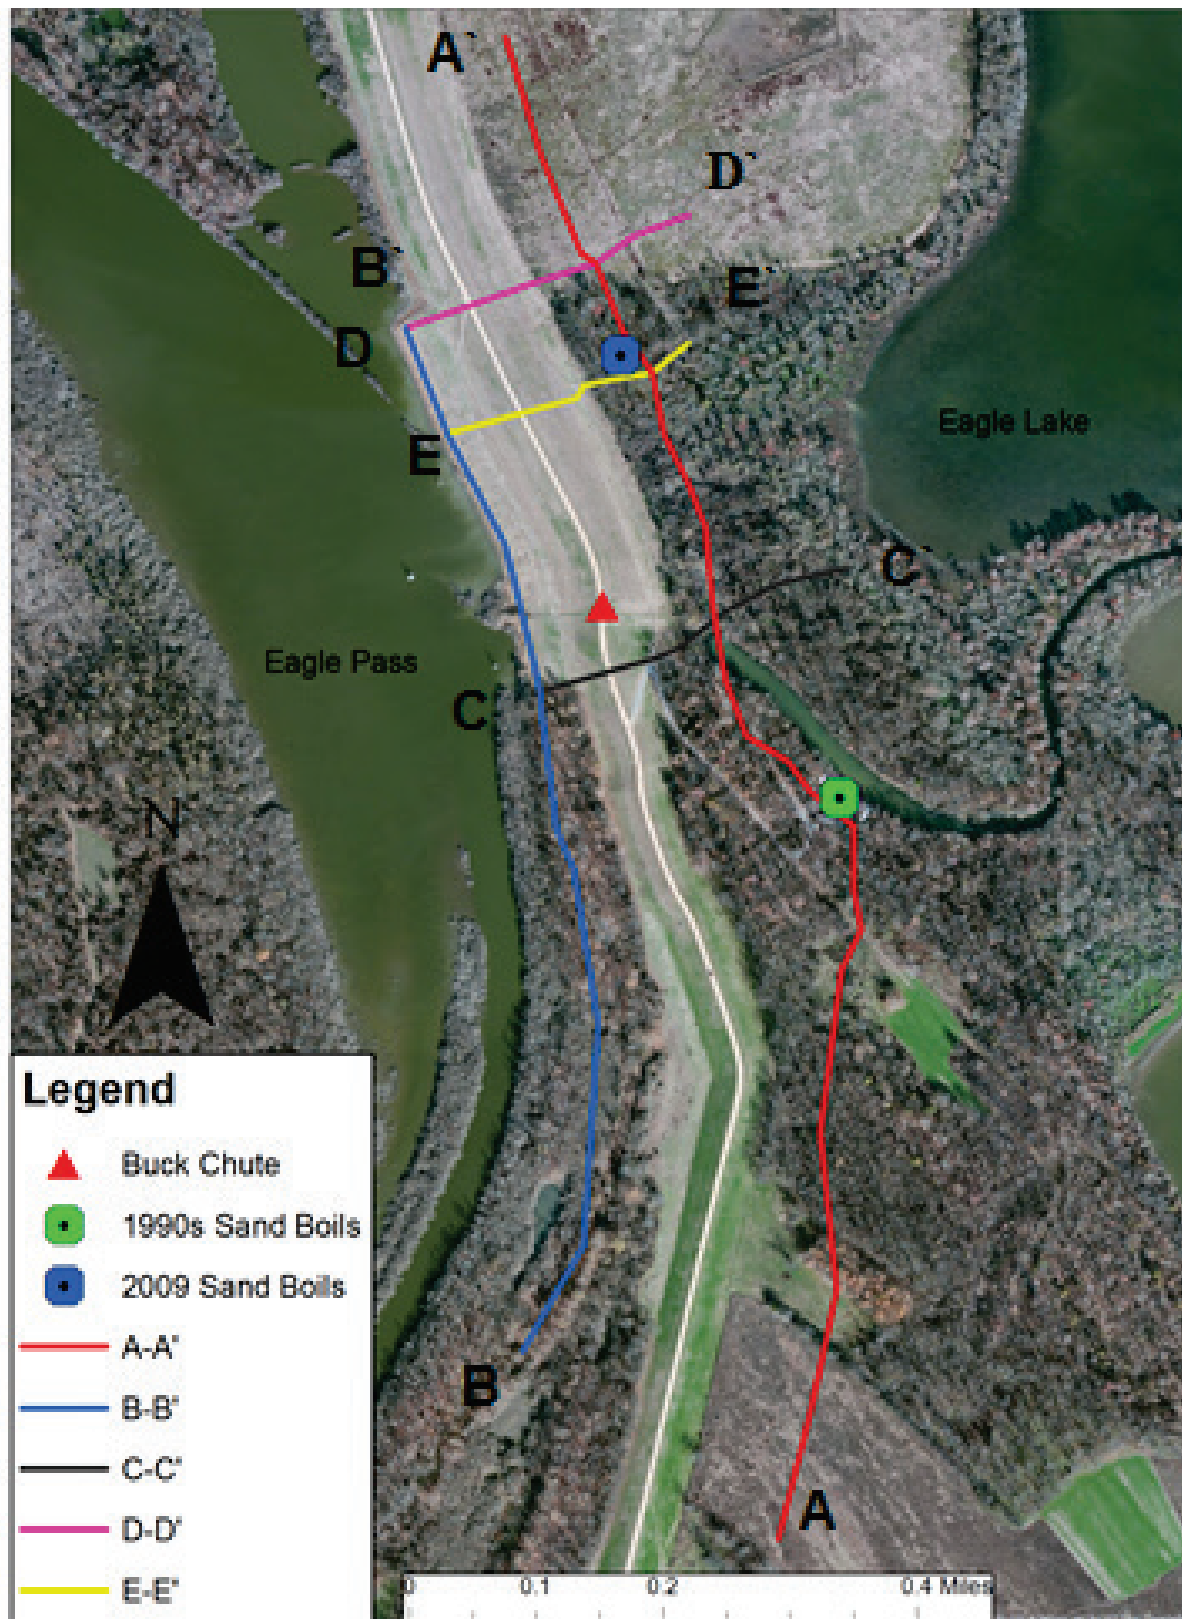
Figure 19. Location map of CPT cross sections (Modified from USGS 1:24000 topographic maps downloaded from ESRI ArcMap 10.1 library).

Five cross sections were produced from the CPT data (Figure 19). Cross sections A-A' and B-B' show the thinning blanket, trending from north to south across the study area, and channel fill deposits. The A-A' section was chosen to run near to the 1990s and 2009 sand boil locations on the land-side of the levee (Figure 20), while B-B' parallels it on the riverside (Figure 21). Near the 1990s boils, the blanket is almost nonexistent; in contrast, the blanket at the 2009 boils is substantial in thickness but begins to thin again toward the north. C-C' is the southernmost west-east cross section; it intersects the batture channel that now is traversed by the levee (Figure 22). C-C' displays an inconsistent blanket in the western portion of the section, which is interfingered with sands and organics, while the eastern portion is more consistent in lithology and thickness. D-D' and E-E' (Figures 23 and 24, respectively) bracket the 2009 boil location. Both show relatively consistent thickness and lithology; however, D-D' does display more lithologic inconsistency toward the northwest portion of the cross section.
